**HARPOON EXPENDABLE TURBOJET MODEL
XJ401-GA-400**

HARPOON EXPENDABLE TURBOJET MODEL XJ401 GA-400

PHASE II FINAL TEST REPORT AND FINAL REPORT

**AiResearch Manufacturing Company of Arizona
A Division of The Garrett Corporation
Phoenix, Arizona**

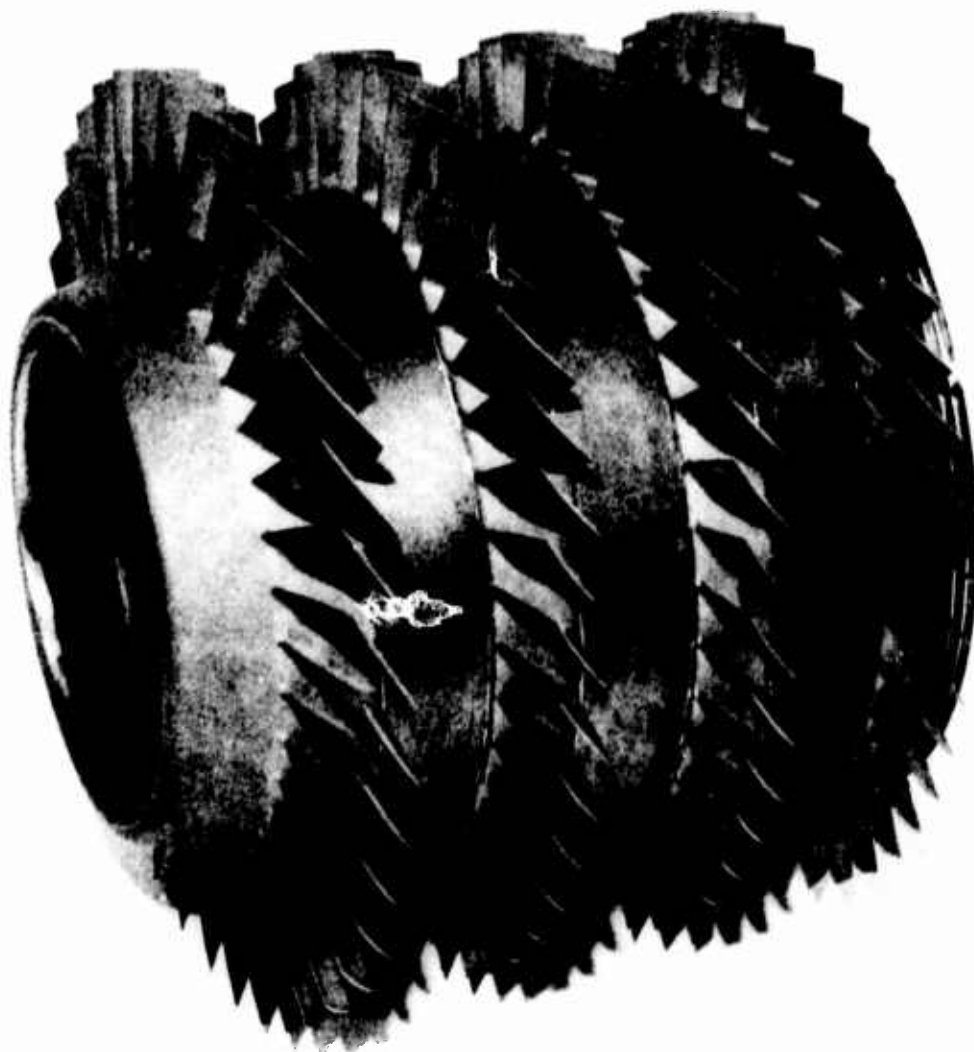
Figure 4. Cast Compressor Rotor.

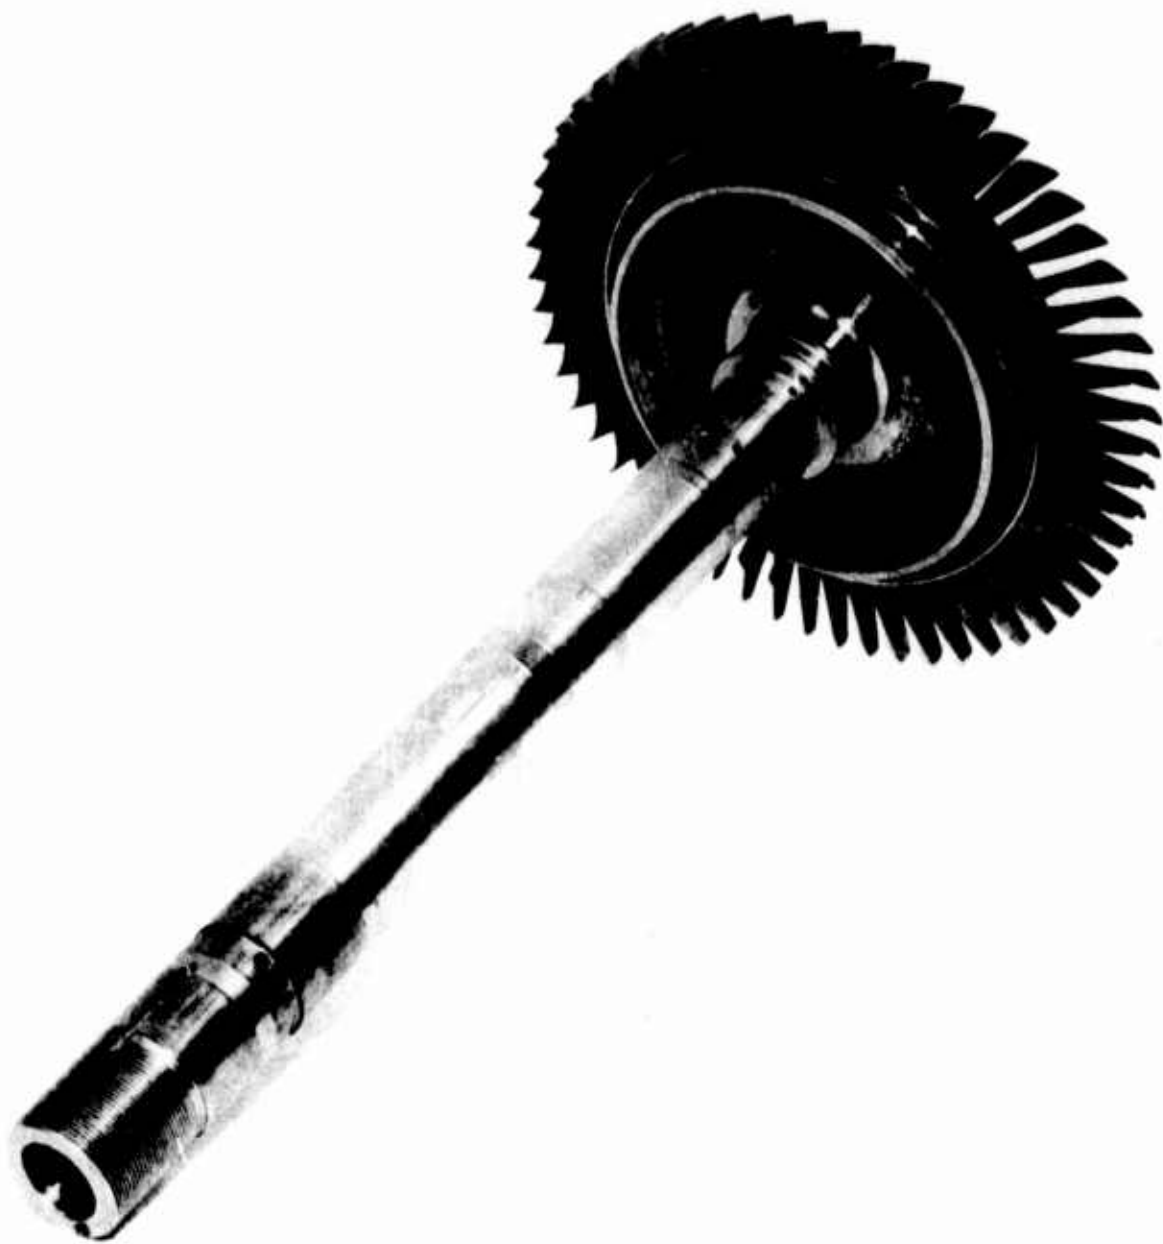
Figure 10. Turbine Wheel and Shaft Assembly. The Final Design is Shown in Figure 52.

The turbine stator vanes and turbine shroud were cast from HS-21 and welded to the combustor. The stator vanes are shown in Figure 9. The turbine wheel and shaft assembly (before cooling improvements) are shown in Figure 10, and the turbine shaft for improved bearing cooling is shown in Figure 49.

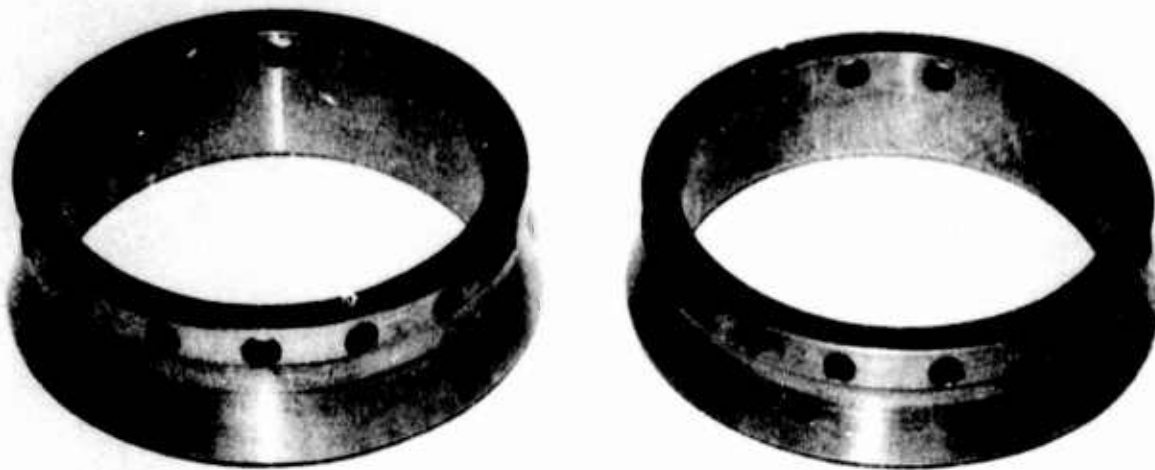
Figure 15. Configuration of Bearing Oil Slingers.
Final Configurations is Shown in Figure 50.

Lubrication was provided by a wick system using DuPont Krytox 143AC as the lubricant. The wick system consists of fiber-glass wicks that carry the lubricant from a fiber-glass batting-packed sump to a conical-shaped slinger by capillary action. Due to centrifugal forces caused by shaft rotation, and airflow across the wick, the lubricant is pumped up the slinger and through the bearing. One wick system is used for each bearing. The change to a roller bearing-ball bearing configuration necessitated a change to the slinger length. The new slingers are shown in Figure 15. Further changes were incorporated as described in Section 4.7 due to low temperature difficulties.

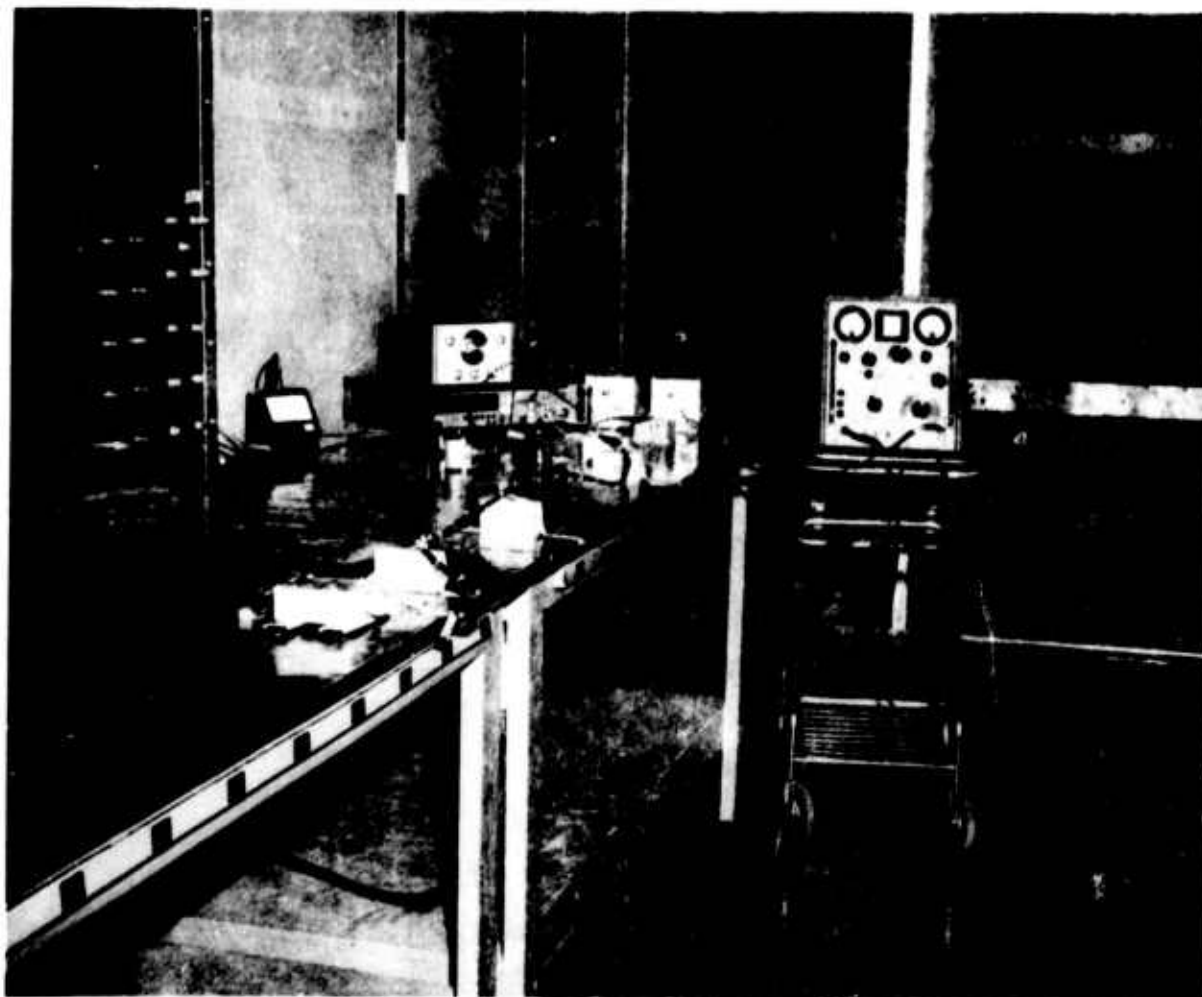
Figure 39. Test Setup Radio-Frequency Conducted Susceptibility.

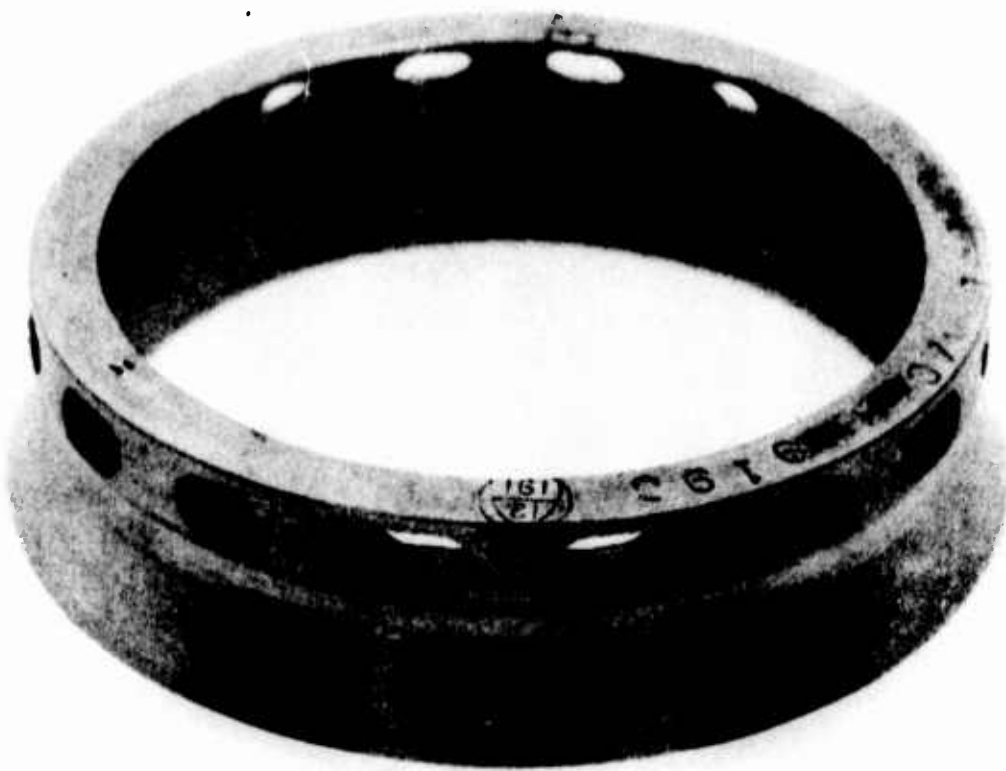
Figure 50. Slinger with Enlarged Cooling Holes.

- o The rear bearing cooling air-flow area was increased 100 percent, by enlarging the cooling air holes in the turbine shaft as shown in Figure 49, and in the slinger as shown in Figure 50. This resulted in a bearing temperature reduction of approximately 150°F during testing.

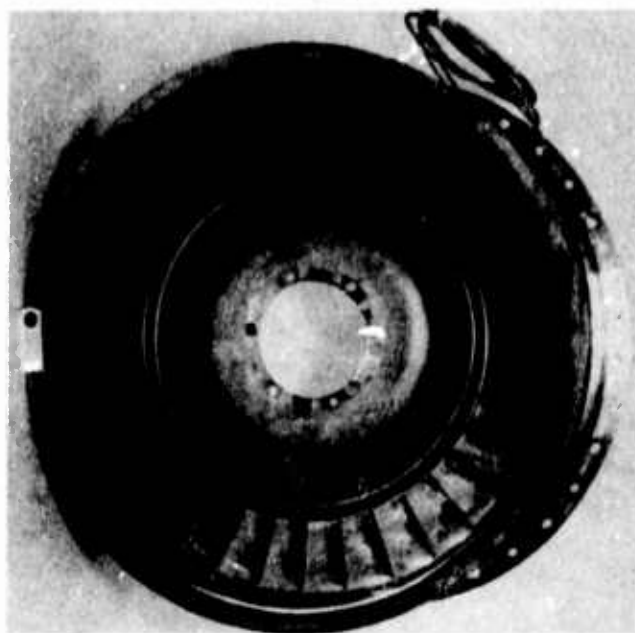
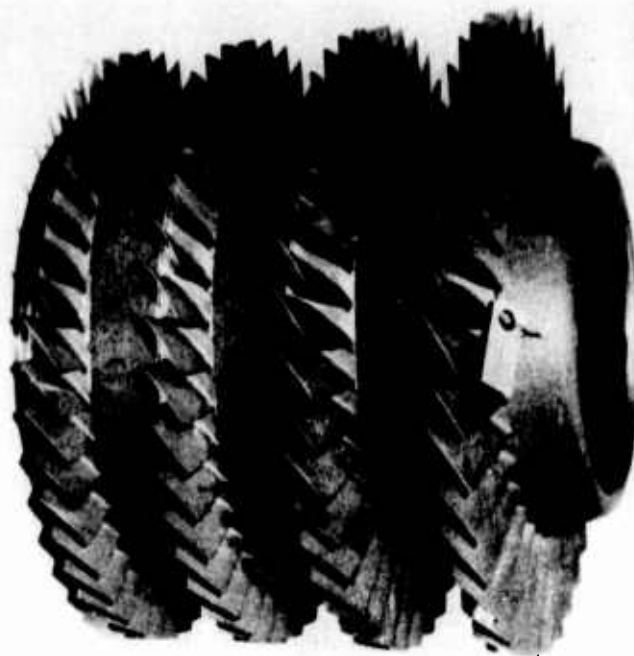
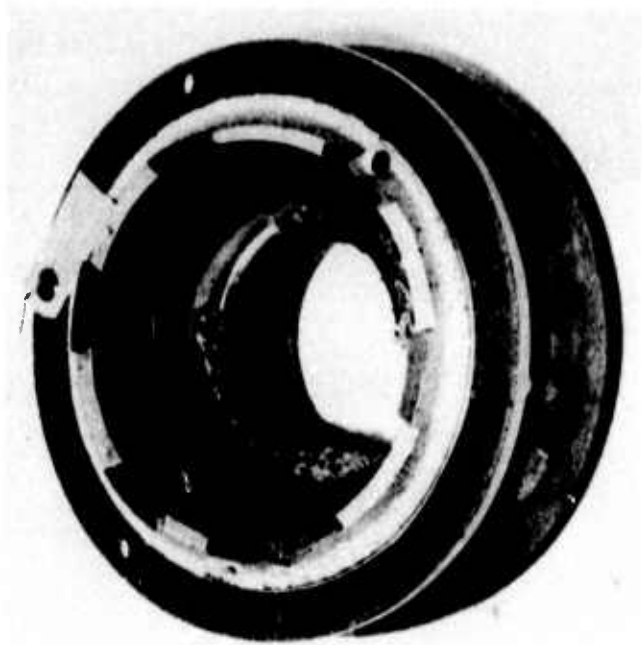
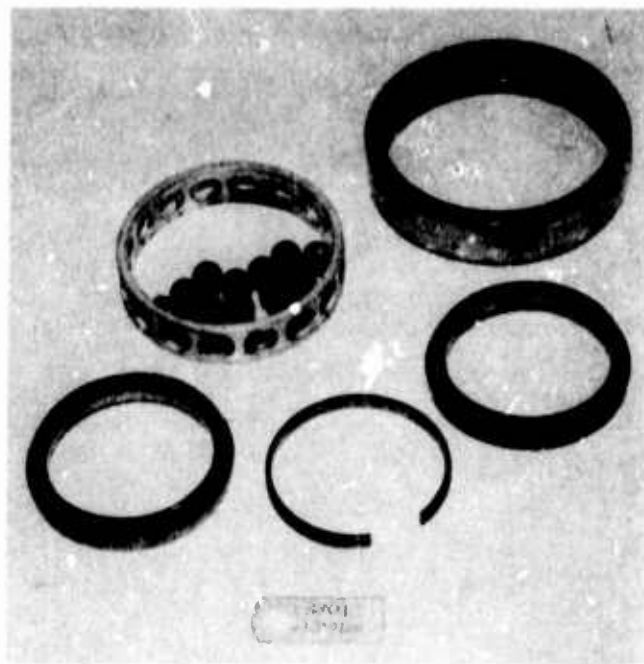
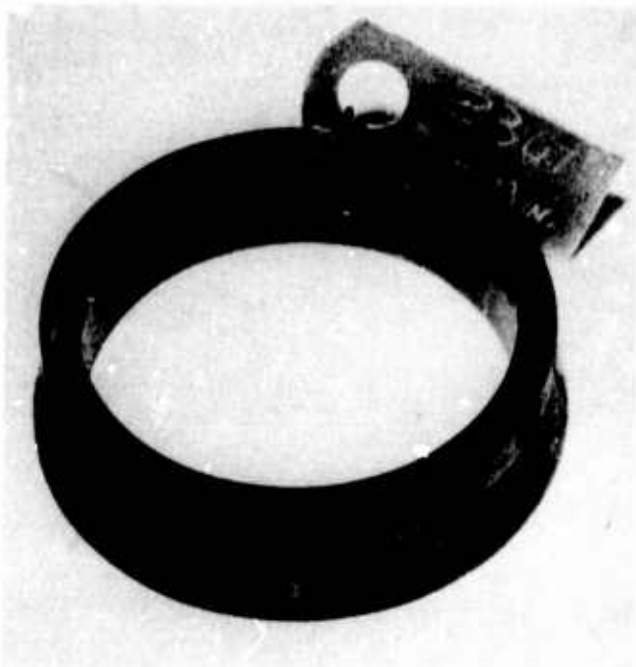
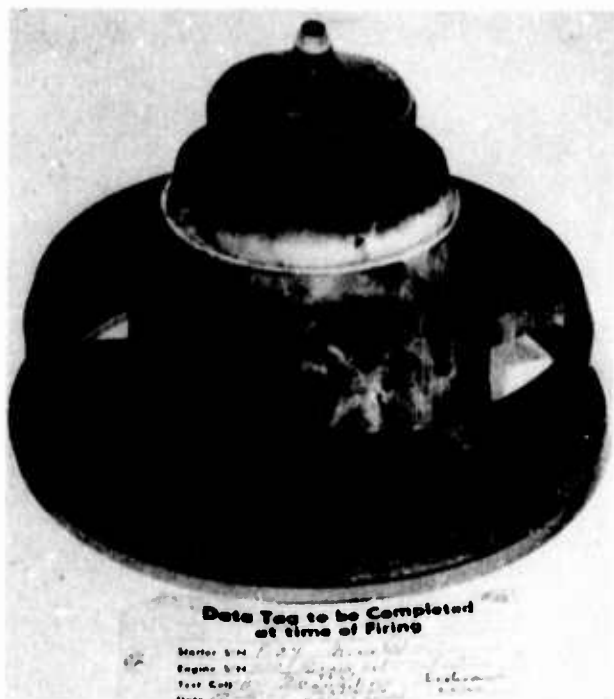
**COMBUSTOR NOZZLE ASSEMBLY (P47043-10)
PART 3740292**

COMPRESSOR HOUSING (P47043-12)
PART 3740270

REAR BEARING CARRIER (P47043-30)
PART 3740409

**BALL BEARING (P47043-22)
PART 3740290-1**

**REAR OIL SLINGER (P47043-23)
PART 3740468**

**STARTER (P47043-8)
PART 3505055**

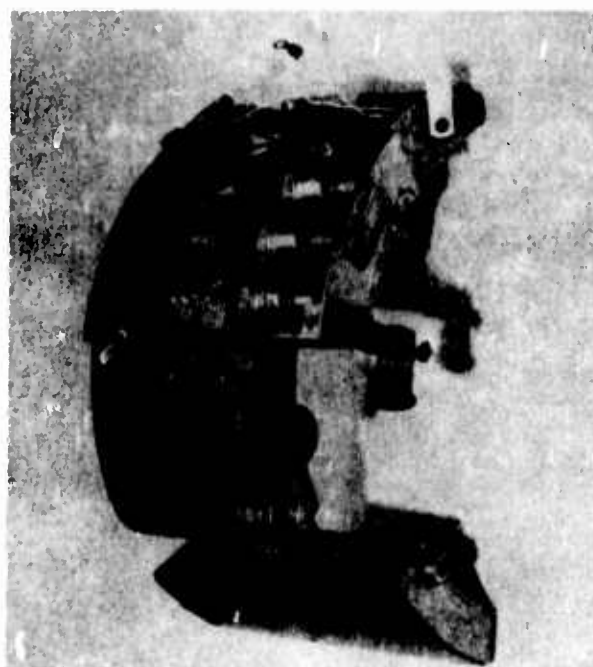
**POWER CONDITIONING UNIT (P47043-7)
PART 3740463-1**

**Figure 57. Post-Endurance Test Parts
(Engine Serial No. 3301)**

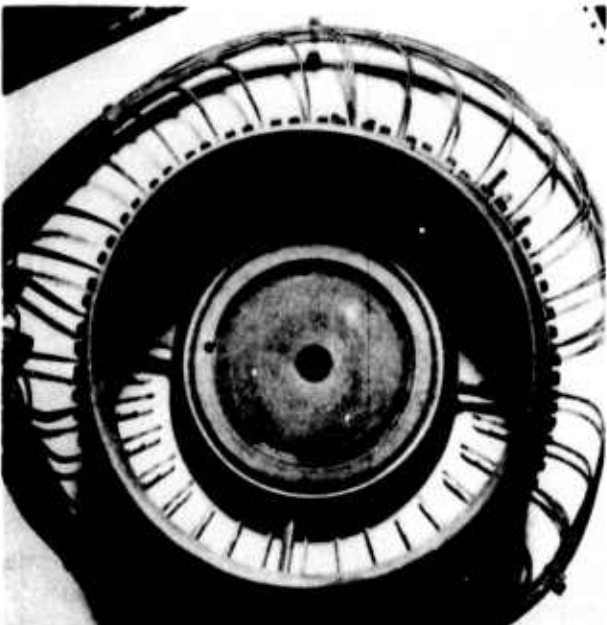
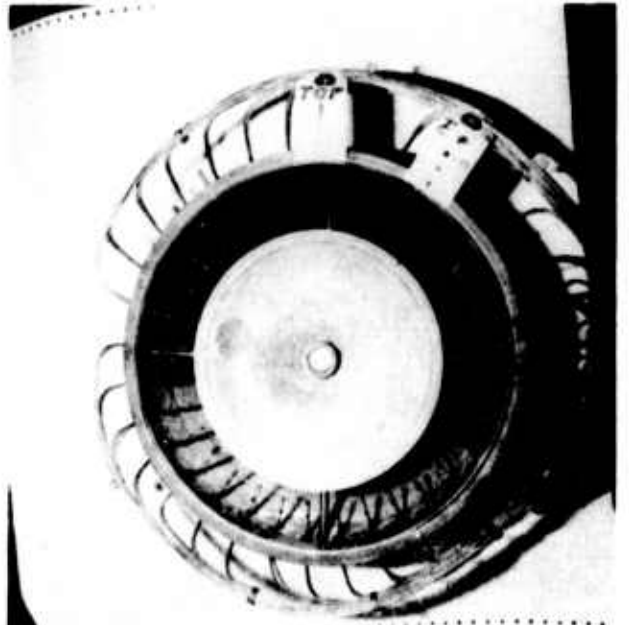
VIEW LOOKING FORWARD

VIEW LOOKING AFT

Figure 75. Instrumented Green-Run Exhaust Nozzle
(T_{t7} Rakes Not Shown).

Prior to the acceptance test, the engine was assembled with the improved diffuser-combustor assembly (see Paragraph 4.9), and subjected to a green-run. The test was conducted on the engine test stand with a special exhaust nozzle equipped with 99 thermocouples to measure T_{t5} as shown in Figure 75. The purpose of the green run was to determine the temperature spread factor (TSF). The maximum allowable TSF at a fuel-air ratio of 0.019 is 0.34. The actual TSF for this engine was 0.23 and the data for this test are contained in Section 6.4. The engine was tested at the following conditions:

to a green run. The test was conducted on the engine test stand with a special exhaust nozzle equipped with 99 thermocouples to measure T_{t5} (see Figure 75). The purpose of the green run was to determine the temperature spread factor (TSF). The limits and conditions for this test are the same as for IFRT No. 1 green run (refer to Paragraph 5.7.1.1). The actual TSF for the engine was 0.23, and the data for this test are contained in Section 6.4.

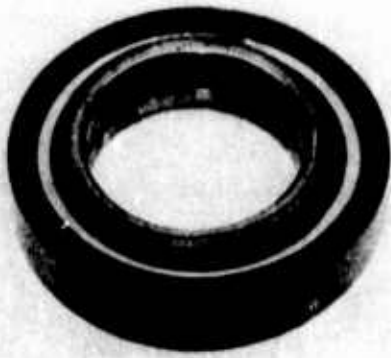
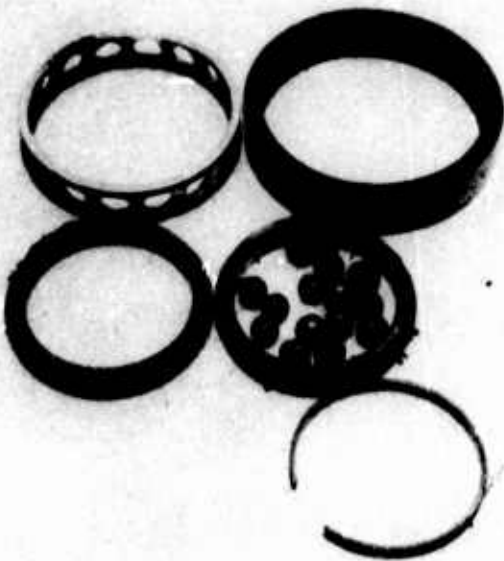
A. BALL BEARING PART 3740290-1
SERIAL NO. 3-106

C. BALL BEARING PART 3740290-1
SERIAL NO. 3-106

Figure 77. IFRT Engine No. 1, Condition of Parts after 20 Minutes
Endurance Run Time. Test Dates: April 6 and 7, 1973.

The ball thrust bearing had experienced distress and all of the sixteen balls showed evidence of metal spalling and melting due to the high temperatures generated. Melted ball material was deposited on the bearing races and on the adjacent end of the alternator. This condition is shown in Figure 77-A,-B, and -C, and Figure 78-A.

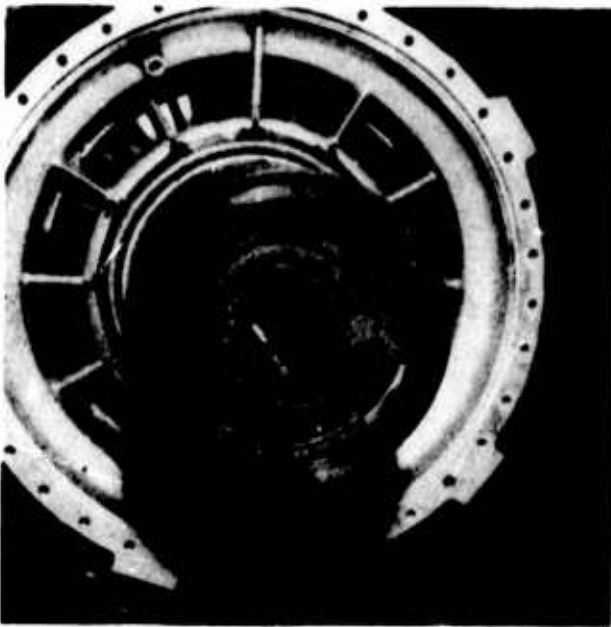
A. MIDFRAME AND ALTERNATOR

B. COMPRESSOR ROTOR PART 3740393-1
SERIAL NO. AC-17

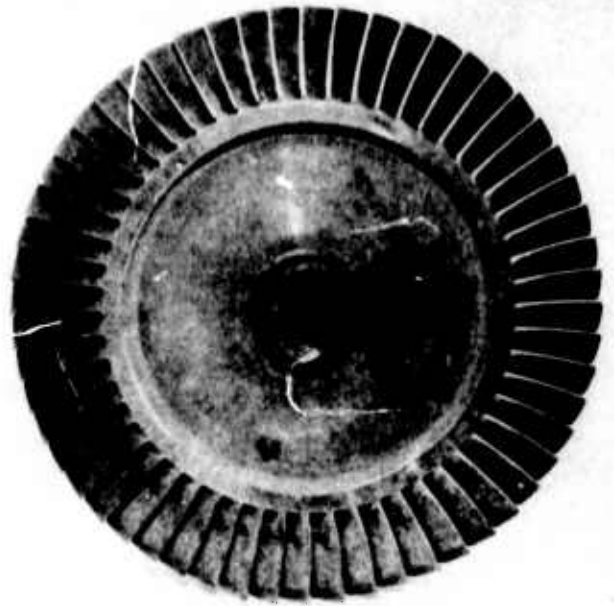
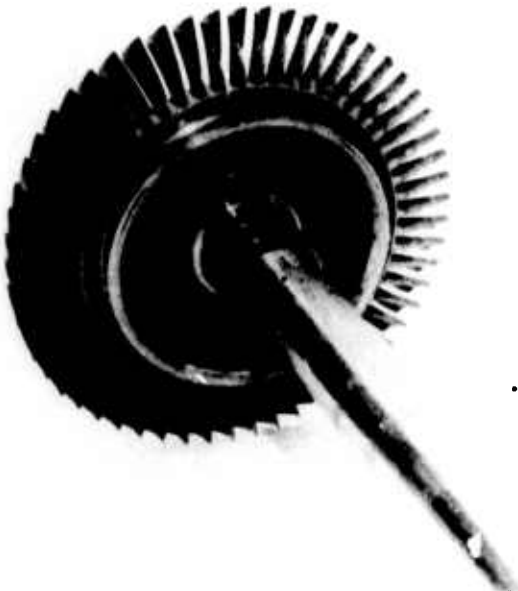
B. TURBINE ROTOR PART 3740283-3
SERIAL NO. 958

C. TURBINE ROTOR AND SHAFT PART
3740283, SERIAL NO. 958

Figure 80. IFRT Engine No. 1, Condition of Parts after 20 Minutes
Endurance Run Time. Test Dates: April 6 and 7, 1973.

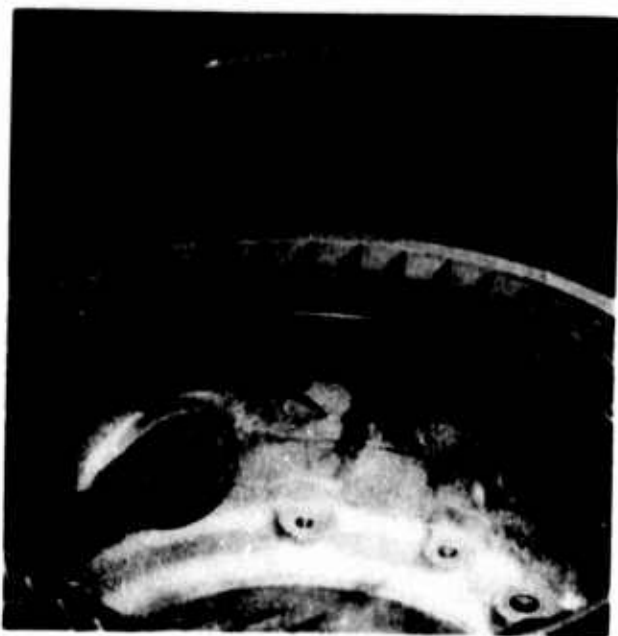
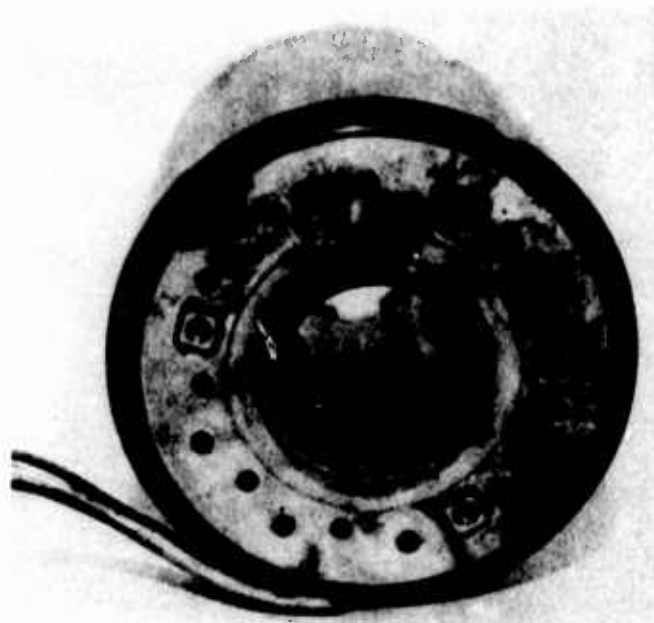
A. MIDFRAME PART 3740387-3
SERIAL NO. 72X126

D. ALTERNATOR PART 2045042-1-1
SERIAL NO. 102-147

Figure 81. IFRT Engine No. 1, Condition of Parts After 20 Minutes
Endurance Run Time. Test Dates: April 6 and 7, 1973.

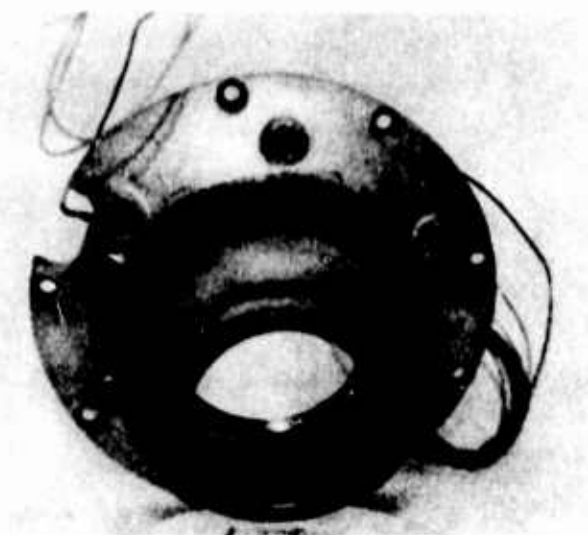
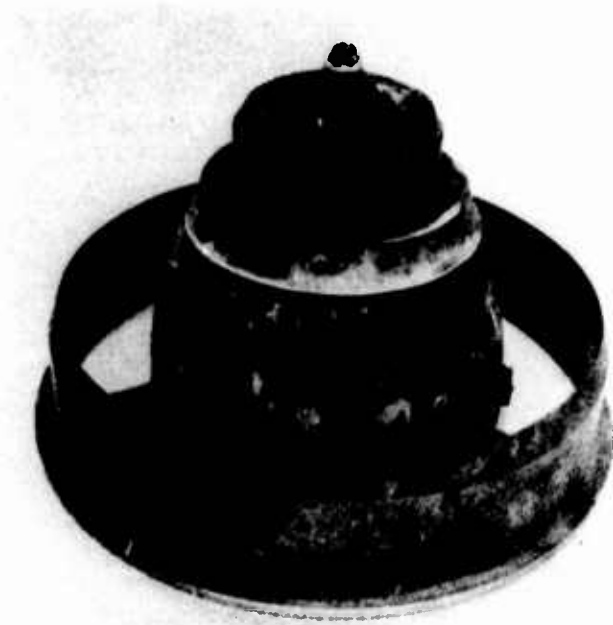
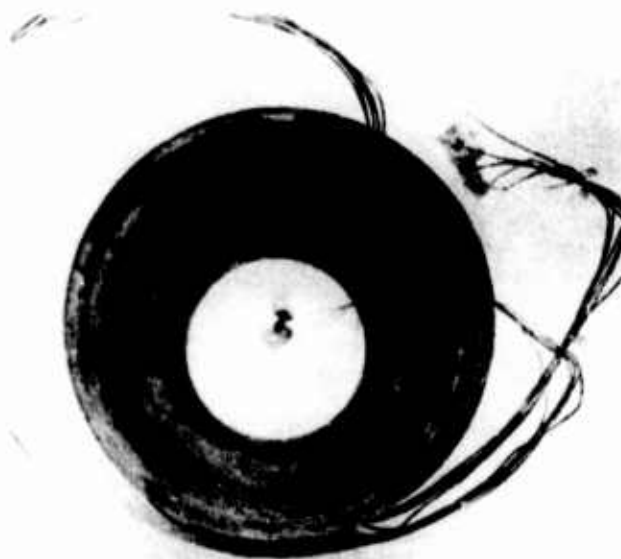
B. FRONT BEARING SUPPORT PART
3740408-1, SERIAL NO. 72X126

C. STARTER PART 3505055-4

D. EXHAUST NOZZLE PART
3500205-1

Figure 82. IFRT Engine No. 1, Condition of Parts after 20 Minutes
Endurance Run Time. Test Dates: April 6 and 7, 1973.

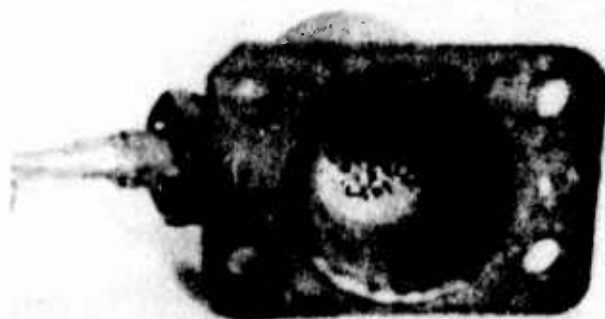
D. PYROTECHNIC IGNITER PART
3740403-1

Figure 83. IFRT Engine No. 1 Condition of Parts after 20 Minutes
Endurance Run Time. Test Dates: April 6 and 7, 1973.

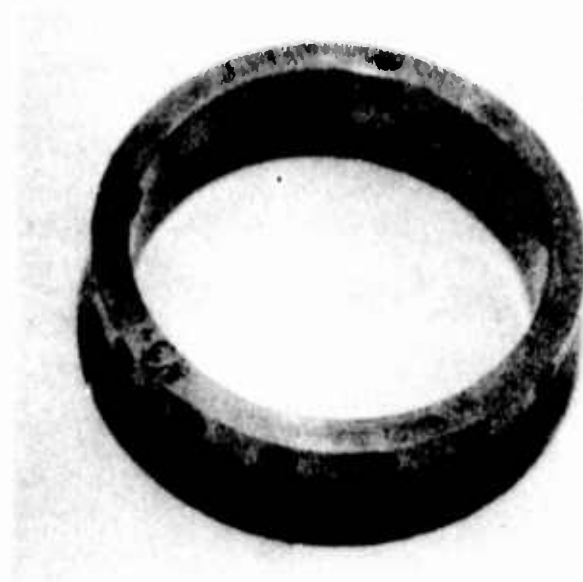
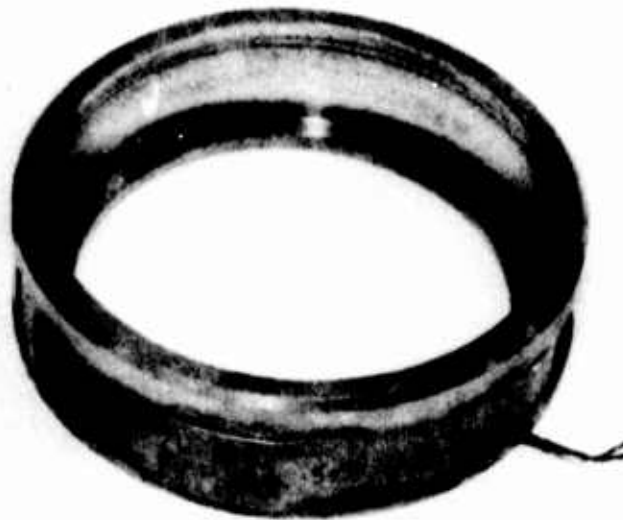
A. OIL SLINGER PART 3740381-1
SERIAL NO. 3

B. RESILIENT MOUNT PART
3740254-1, SERIAL NO. 3

Figure 84. IFRT Engine No. 1, Condition of Parts after 20 Minutes
Endurance Run Time. Test Dates: April 6 and 7, 1973.

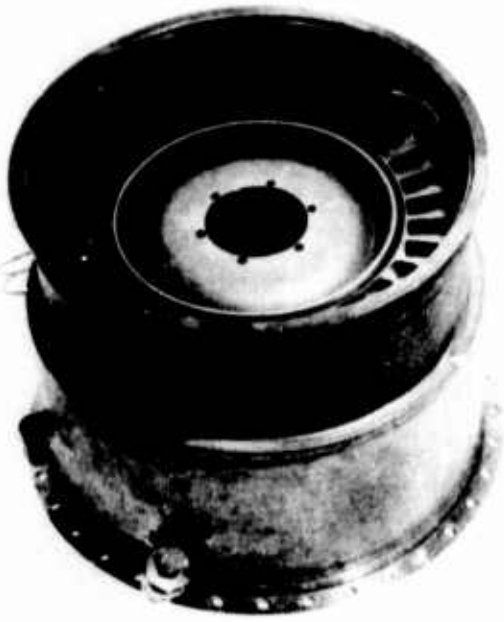
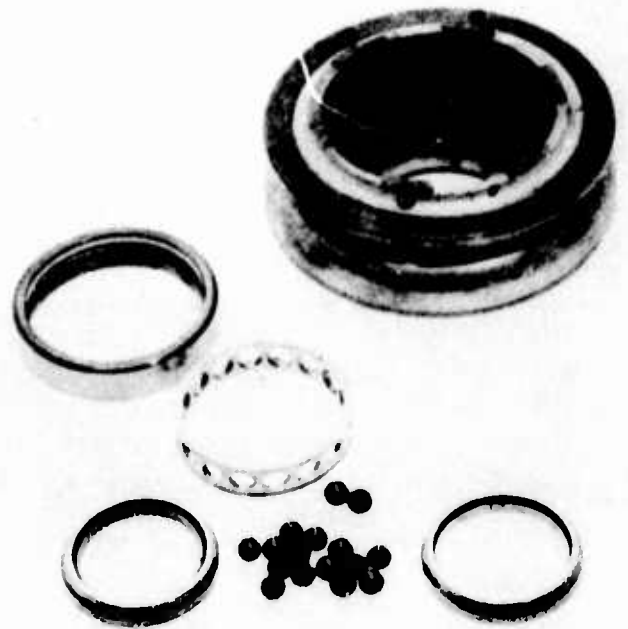
Figure 90. IFRT Engine No. 2, Condition of Parts after 26 Minutes
Endurance Run Time. Test Dates: March 30-April 4, 1973.

A. COMBUSTOR AND NOZZLE PART
3740292-3, SERIAL NO. 1480

C. COMBUSTOR AND NOZZLE PART
3740292-3, SERIAL NO. 1480

D. THRUST BEARING AND SUPPORT
PART 3740290-1, SERIAL NO
3-102.

All other parts were in excellent condition, as shown in Figures 90-A,-B,-C; 91-B,-C,-D; 92; and 93. The effective area of the combustor/nozzle assembly (see Figure 90-A,-B, and -C) was determined by a flow test to be 12.10 square inches. This is an increase of 1 percent over the 11.98 square inches measured before assembly and test of the engine. This variation is within acceptable limits.

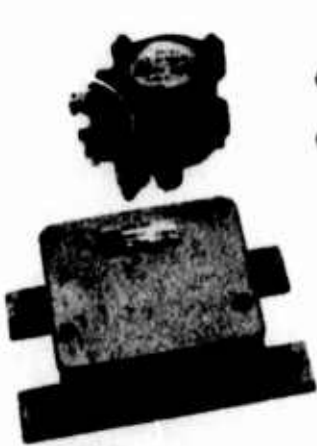
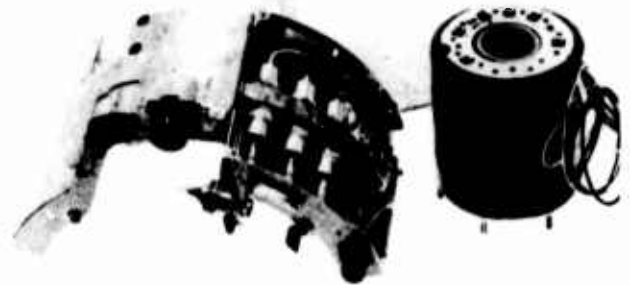
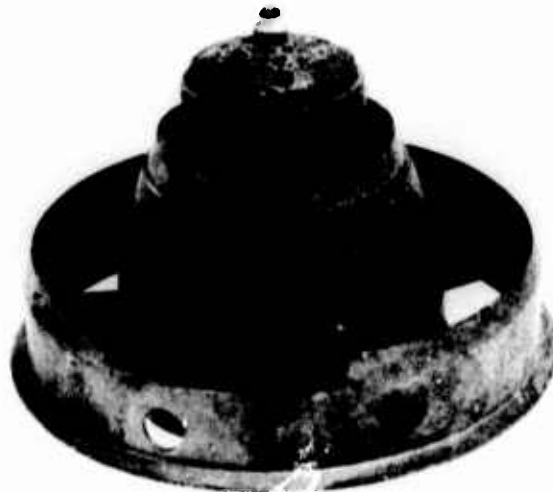
A. FUEL CONTROL SYSTEM

B. ELECTRICAL SYSTEM

C. STARTER PART 3505055-4

Figure 92. IFRT Engine No. 2, Condition of Parts after 26 Minutes Endurance Run Time. Test Dates: March 30-April 4, 1973.
